## **Experimental Evaluation of the Failure of a Seismic Design Category – B Precast Concrete Beam-Column Connection System**

December 2014

Final report

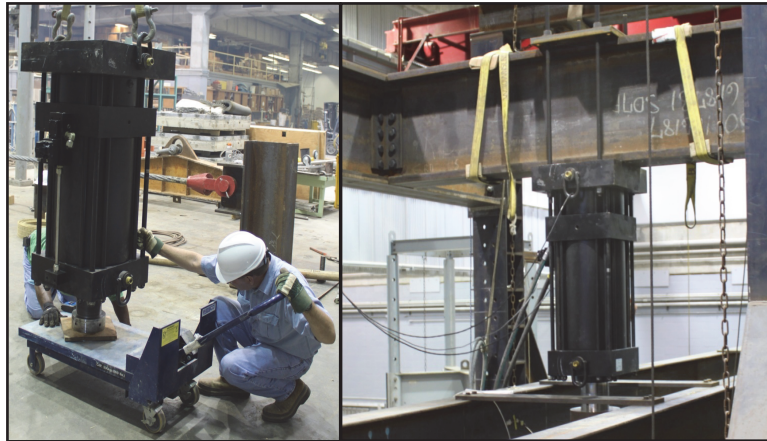
Figure 5. View of the 600-kip hydraulic ram.

A hydraulic ram with a capacity of 600 kips and a 20-in. stroke (Figure 5) was used to apply a vertical downward load to the center column of the test specimen. The load was applied under ram displacement control at a rate of 1 in. per minute.

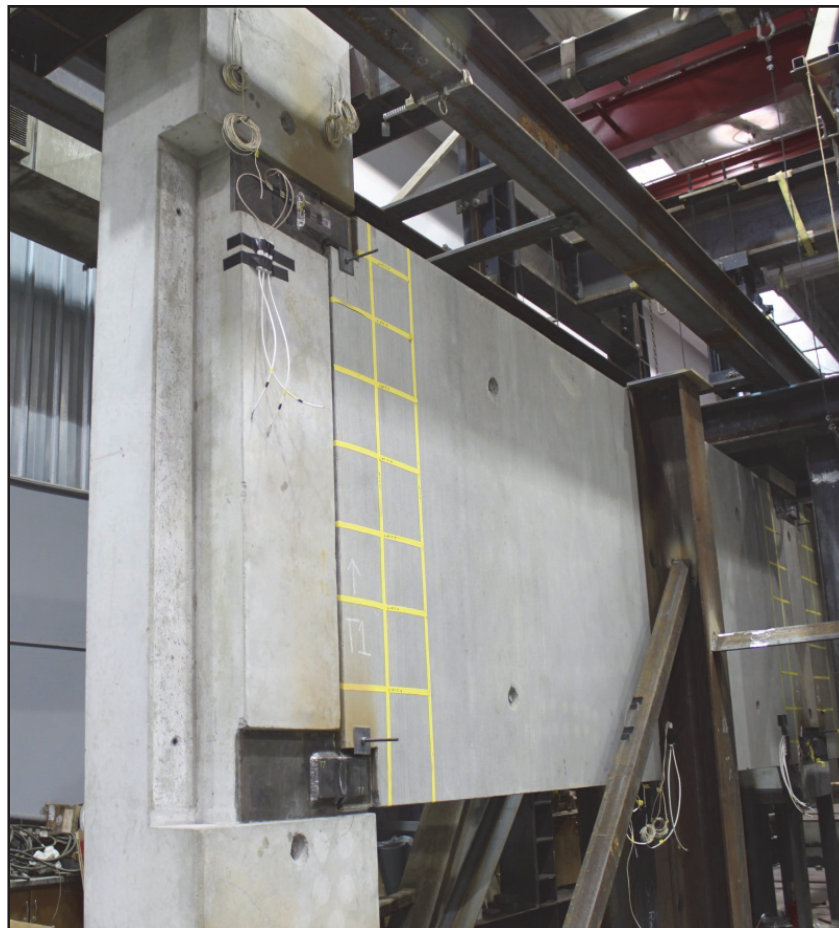
Figure 13. A36 ductile connecting plate and torsion rod beam connecting elements.

embedded angles (M6) were two 7.67-ft-long #10 anchor bars. Anchor bars were a key design parameter for the SDC-B test specimen. Two #10 steel reinforcing bars were used to provide tensile resistance and anchor the embedded steel connection plates to the ends of the moment resisting beam-column connection. Details of these connections are shown in Figure 11. Each beam was placed on the column on top of a 0.5-in. bearing pad and connected to the columns using 1-in.-by-5.5-in.-by-12-in. connecting A36 steel plates welded to the embedded angles in each of the corners of the beams and to the embedded plate on the columns shown in Figure 12. Figure 13 illustrates a typical view of the beam-column connection method. These ductile connection steel plates were made of ASTM A36 steel. In addition, four torsion rods were installed through the beam-column connections. The purpose of these rods is to maintain the system aligned by resisting torsion forces on the beams.

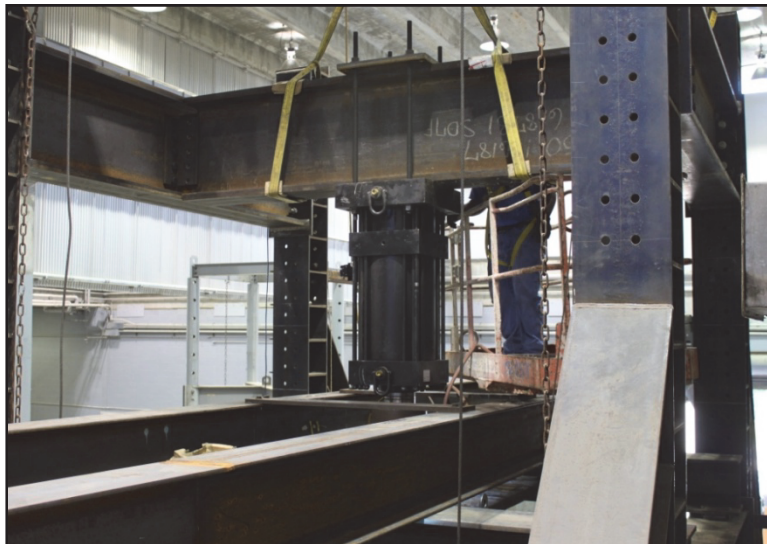
Figure 15. SDC-B hydraulic static ram installation.

A hydraulic ram was used to apply a vertical downward static load to the center column of the test specimens while the load was recorded using an external 400-kip load cell installed at the end of the stroke (Figure 14). A differential pressure sensor inside the 600-kip servo-hydraulic actuator (ram) was used to record the hydraulic pressure exerted on the piston rod. Figure 15 illustrates where the ram was anchored during the test.

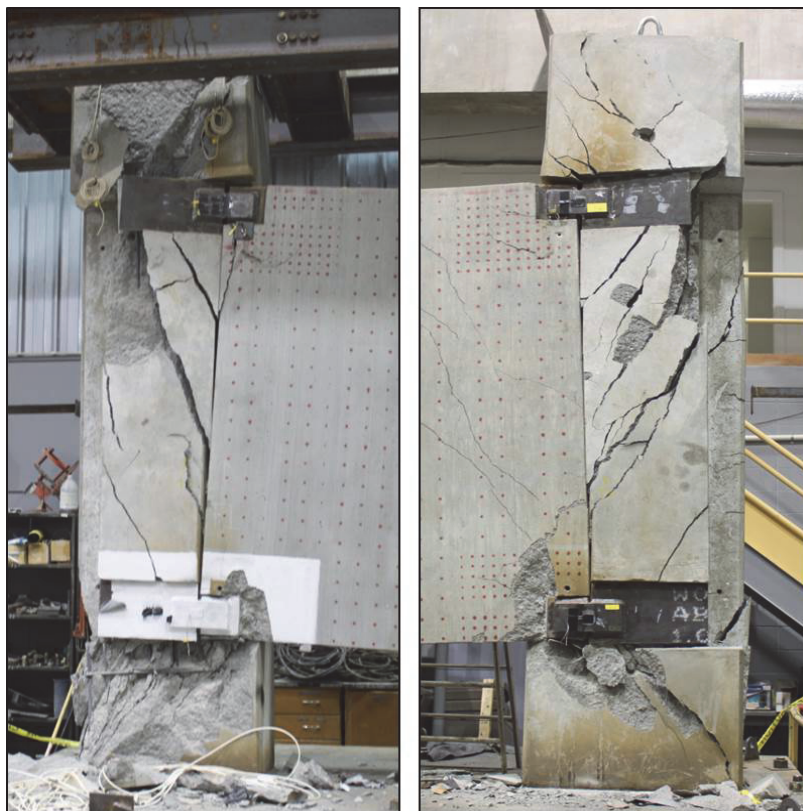
Figure 42. Location of M7 anchor bars in Beam L, brittle failure.

The second event (II) is linked to a brittle failure of the bottom anchor bar welded to the (M7) embedded angle in the left beam. Figure 42 shows the location of the ruptured anchor bar. The tensile failure of the bar occurred when the system reached the 125-kip vertical load mark and had a vertical center displacement of 2.1 in. (at 150 min). The brittle failure of this bar caused the system to become more unstable resulting in a gradual change in center deflection without a significant change in applied load. This event was also captured by the strain rosettes gauges on the ductile connection plate #3, and the strain gauges located on the M7 top anchor bar (eh-45 and 46). Figure 43 depicts the change in strain on the connection plate #3 due to the brittle failure of the (M7) bottom anchor bar.

The fourth event (IV) is directly related to the failure of the top anchor bar of the (M7) embedded angle in the left beam. Please refer to Figure 42 for the location of the M7 top anchor bar. The bar failed when the system reached its capacity at the 175.5-kip load mark and had a vertical center displacement of 5.8 in (at 216 min.). Figure 48 illustrates both of the ruptured M7 anchor bars.

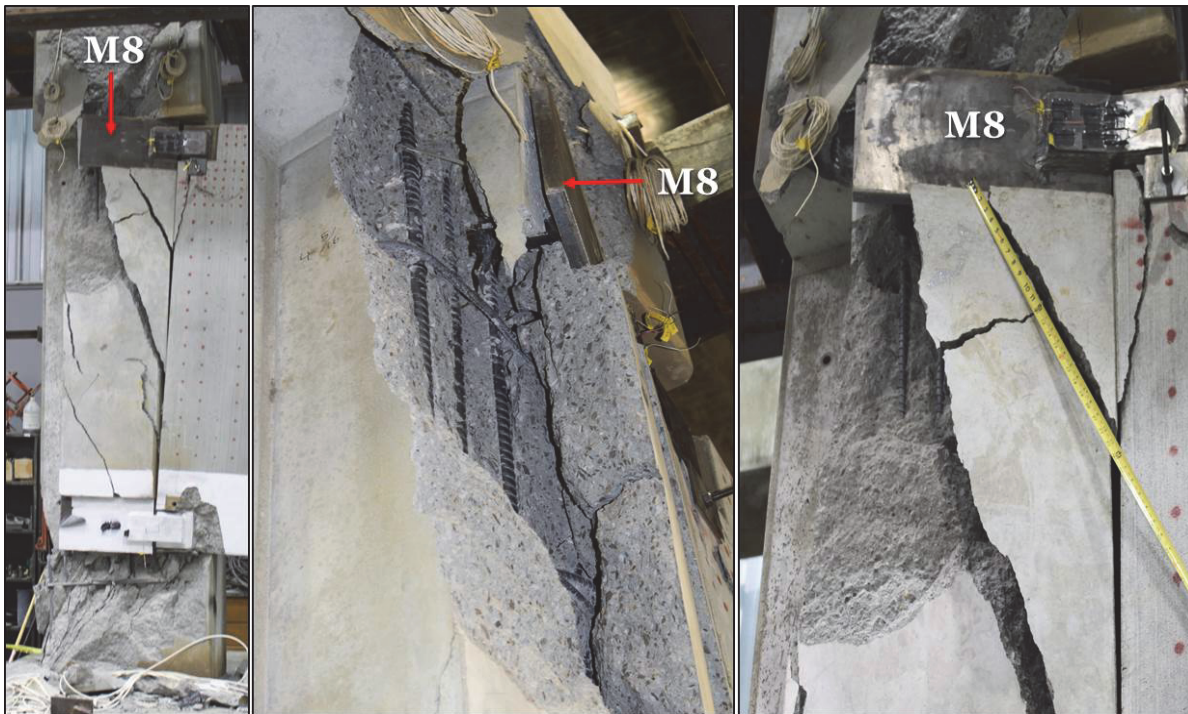
Figure 45. Left (east) end column, failure of top embedded plate M8.

The third event (III) could be linked to a connection failure of M8 steel plate and the left (east) end column. At the time the system reached the 128-kip vertical load mark and had a vertical center displacement of about 4.0 in. (at 185.5 min), the spalled concrete began to fall from both of the end columns.

Each of the M8 plates were embedded to the columns using 1-in.-by-4-in. HCA nelson studs, Appendix A: SDC-B Instrumentation Drawings. The top left end column plate (M8) was pulled out of the concrete due to the high magnitude bending moments that cracked the column and consequently reduced the connection strength of the nelson studs and the concrete. Figure 39 show that the system ability to carry load reduced, however it ramped again. Figure 45 shows the structural damage of the left end column.

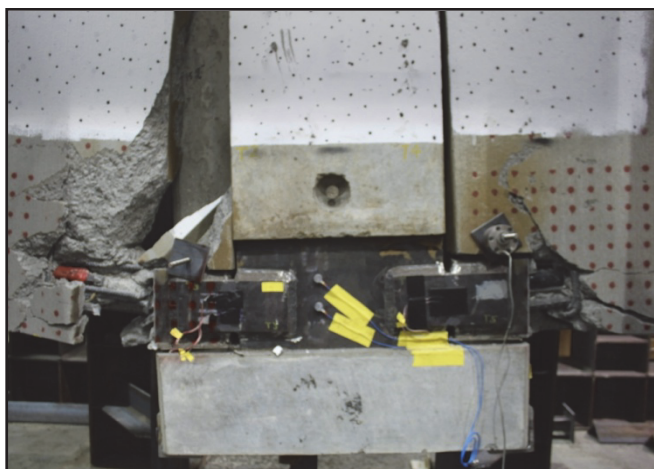
Figure 52. Posttest center stud rotation toward the right (west) end column.

Also an increase in rotation of the center stud toward the right end column was observed soon after the M7 top anchor bar failed. Figure 52 illustrates the misalignment of the center stud from the center line towards the right (west) end column. Figure 53 depicts the displacement profiles of the beams (D-83 through D-88) at different load measurements. In this figure, dotted lines are used to connect the measured deflections. Notice how the differences between the displacement measurements on each side of the center column increase once the system reached its capacity and the top M7 anchor bar fractured.

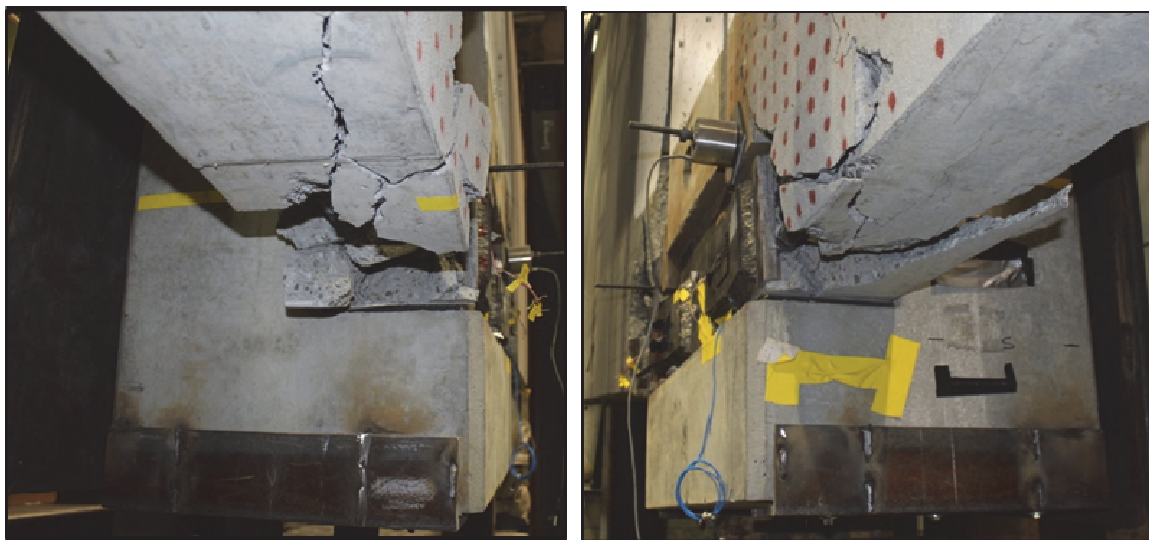
Figure 56. Posttest views of the bottoms of the SDC-B beams, full-depth cracks.

Near the end of the compressive membrane action range, the system transitioned to almost a pure state of tension membrane under large deflections. The system formed a catenary behavior. Even though none of the ductile connection plates failed, (Figures 57 to 64), the top anchor bar welded to the bottom left connection of the center stud (M7) failed, (Figure 48). Once both M7 anchor bars fractured, the ductile connection plate #1 was no longer interacting with the system. Therefore, the bending moment was redistributed to the remaining (7) ductile plates, causing the system to rotate even more toward the right end column. The system continued being loaded until it reached a total center vertical displacement of 18.5 in.
